OSHC “Barqi Tojik”

# **Baipaza Landline** ***History and Modern Issues***

Ischuk N.  
2012

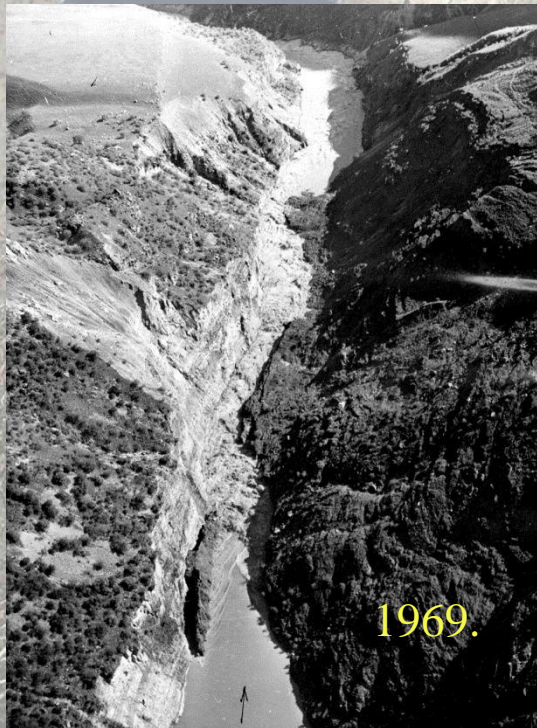
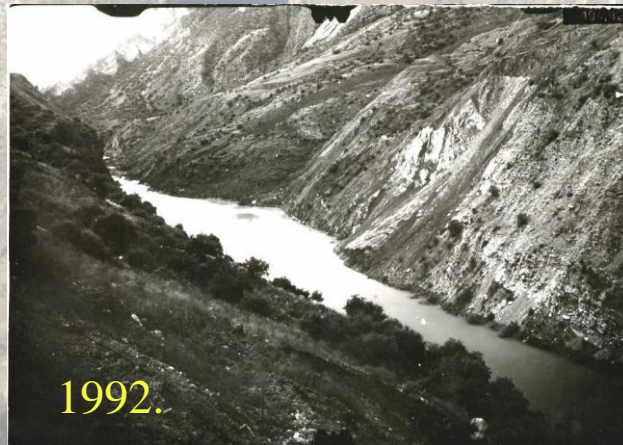
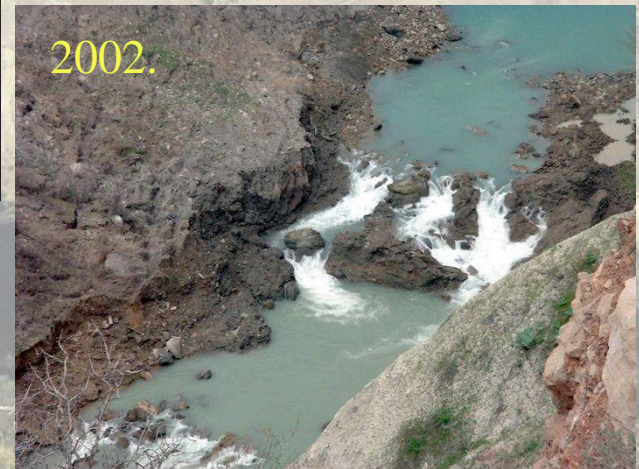
- Baipaza landslide was brought to attention first time in 1969, when it blocked the Vaksh river. The Baipaza Hydro Power Station did not exist then.
- The second time the landslide occurred in 1992 which blocked the river and carried a threat of floods in Baipaza HPS.
- Last time Baipaza landslide blocked the Vaksh river in March of 2002.

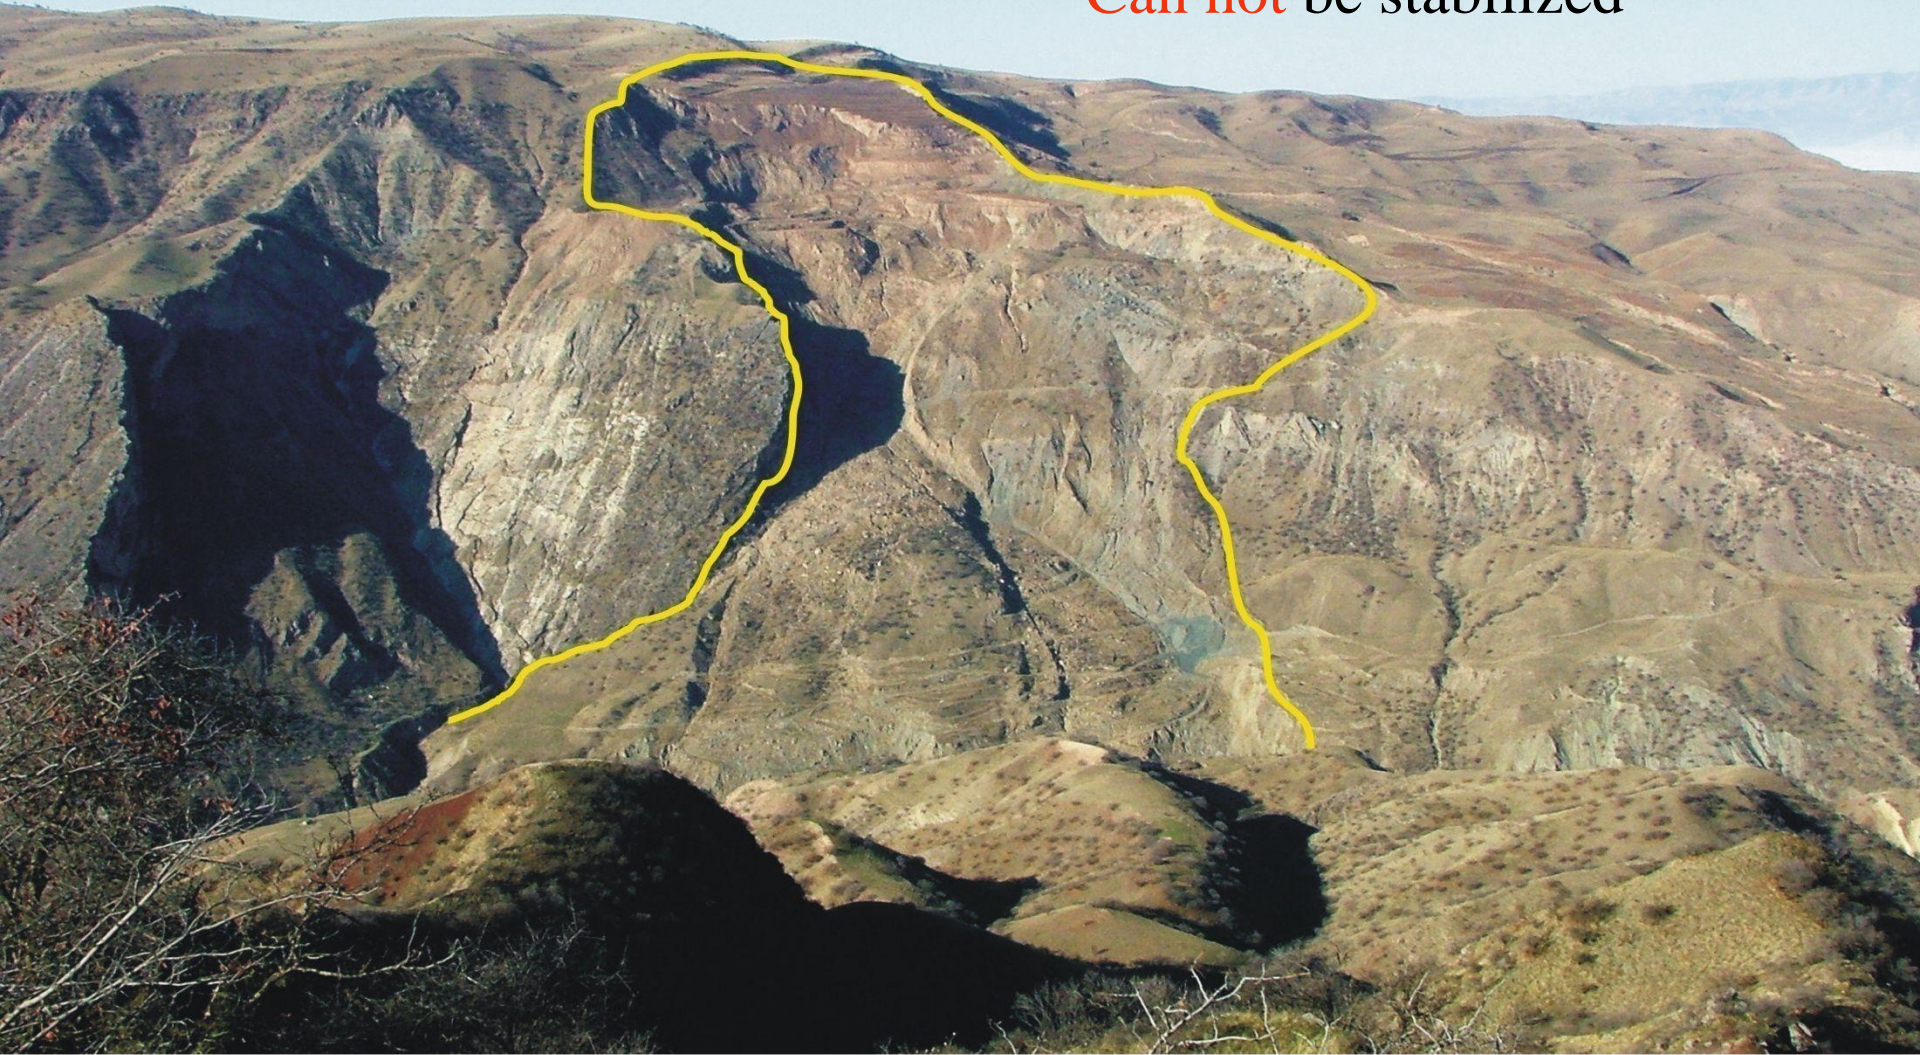
# Baipaza Landslide

Area— 640 000 m<sup>2</sup>

Volume— 23 mln.m<sup>3</sup>

Status: **Active**

**Can not** be stabilized

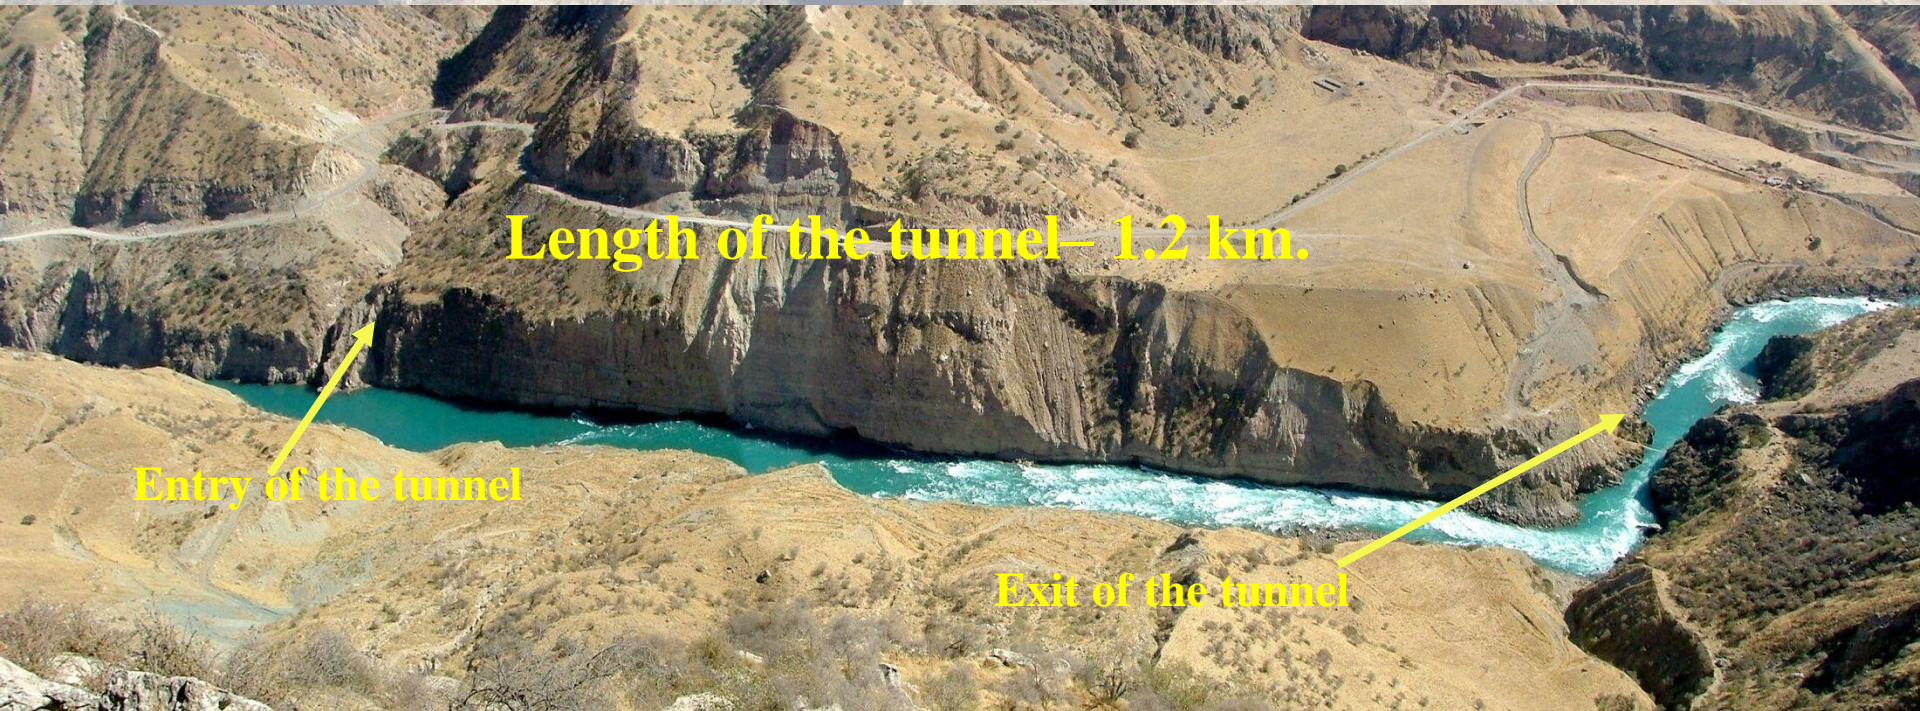
# What Could Have Been Done in 2002?

Save time in building tunnel in order to bypass water of in Vakhsh river during the landslide blockage..

Estimated Cost of Construction— around \$ 32 mln.

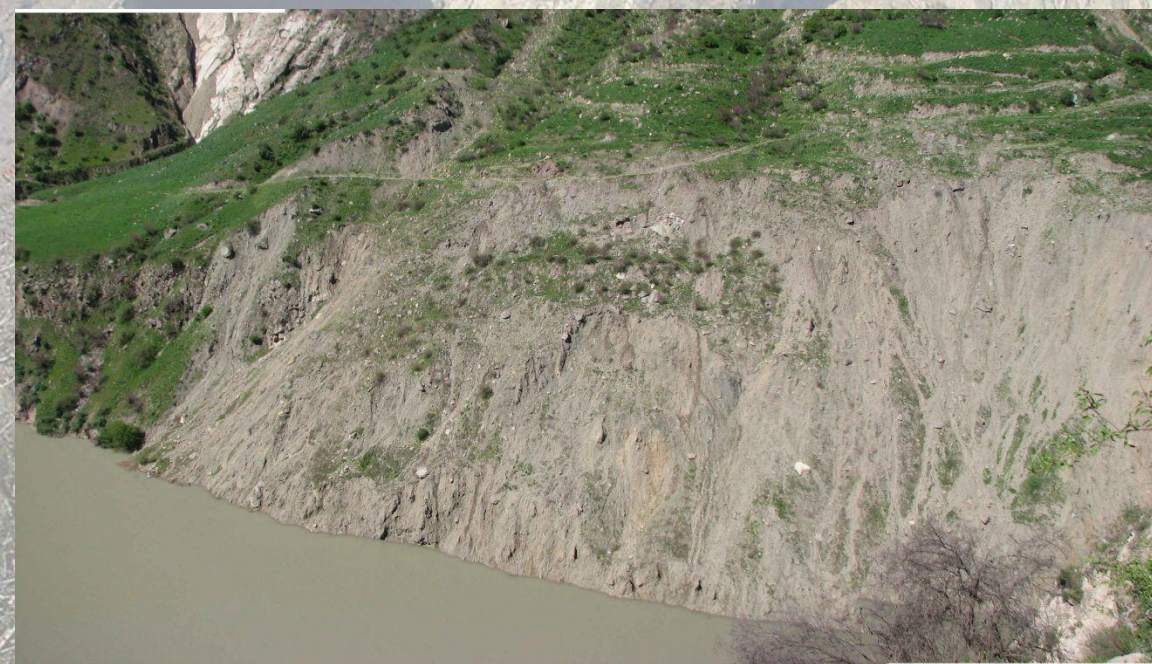
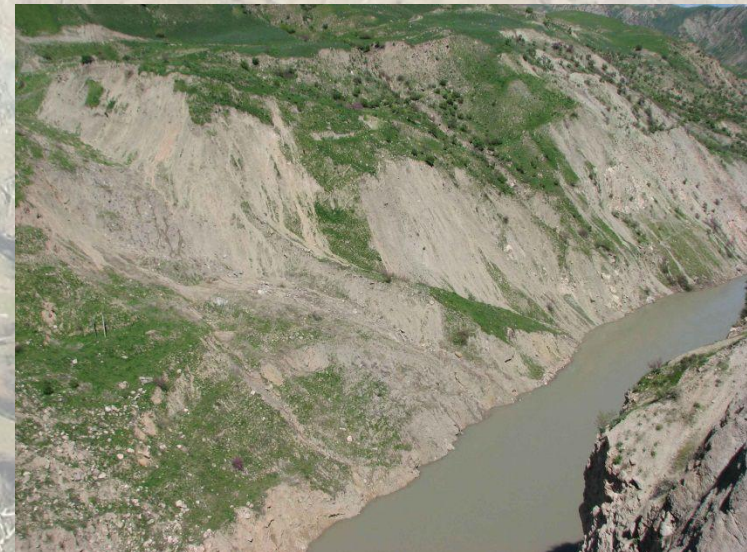
# Modern Status

- The most dangerous parts of the Baipaza landslide are the "neck", the northern and southern part of the riverbed.
- Erosion of the possible water blockage, as it was before the creation of the reservoir Sangtuda-1, will not occur, which will create additional difficulties in the elimination of overlapping.

- Baipaza landslide is an active landslide and can not be forecasted;
- Stabilization of the landslide is not possible with modern technology;
- Baipaza landslide - is the sword of Damocles for hydropower system in Tajikistan;
- *It is imperative to immediately commence the constriction of emergency tunnel, which would allow to function HPS in case of Vakhsh river blockage.*
