# **Initiation zones of debris flows and glacial disasters:**

**research experience of Moscow University**

-----  
*Regional Climate Risk Resilience Workshop on "Fostering Resilience to Remote Geo-Hazards"*

*Dushanbe, Tajikistan, 2 June 2010*

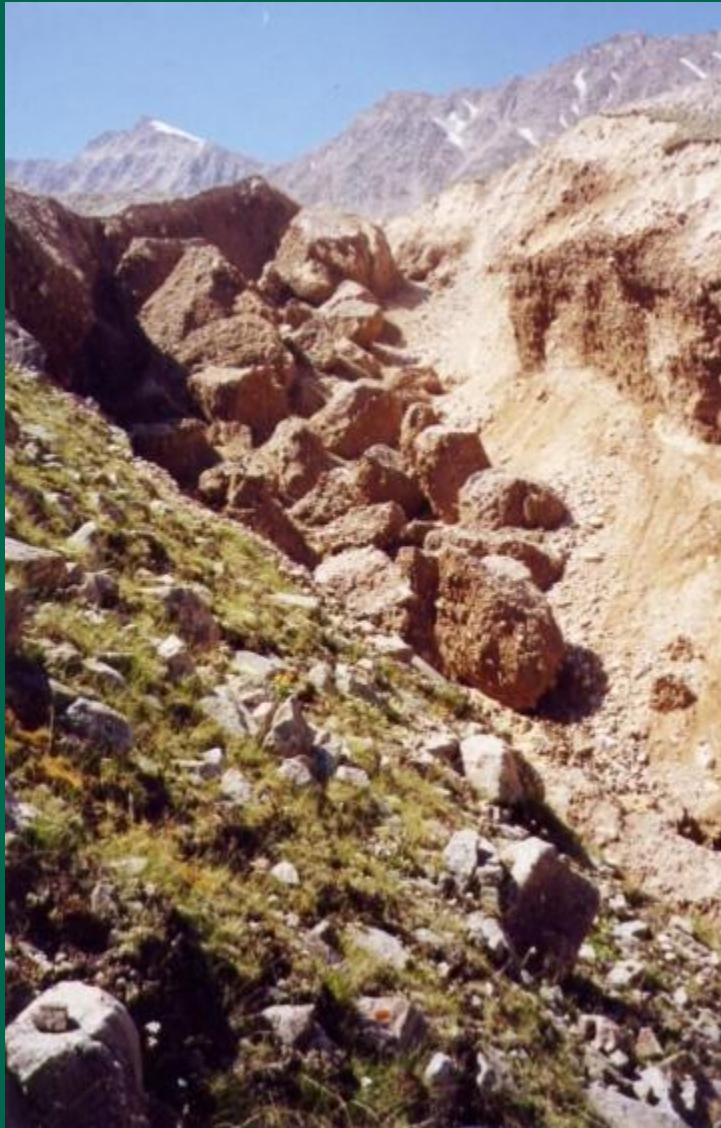
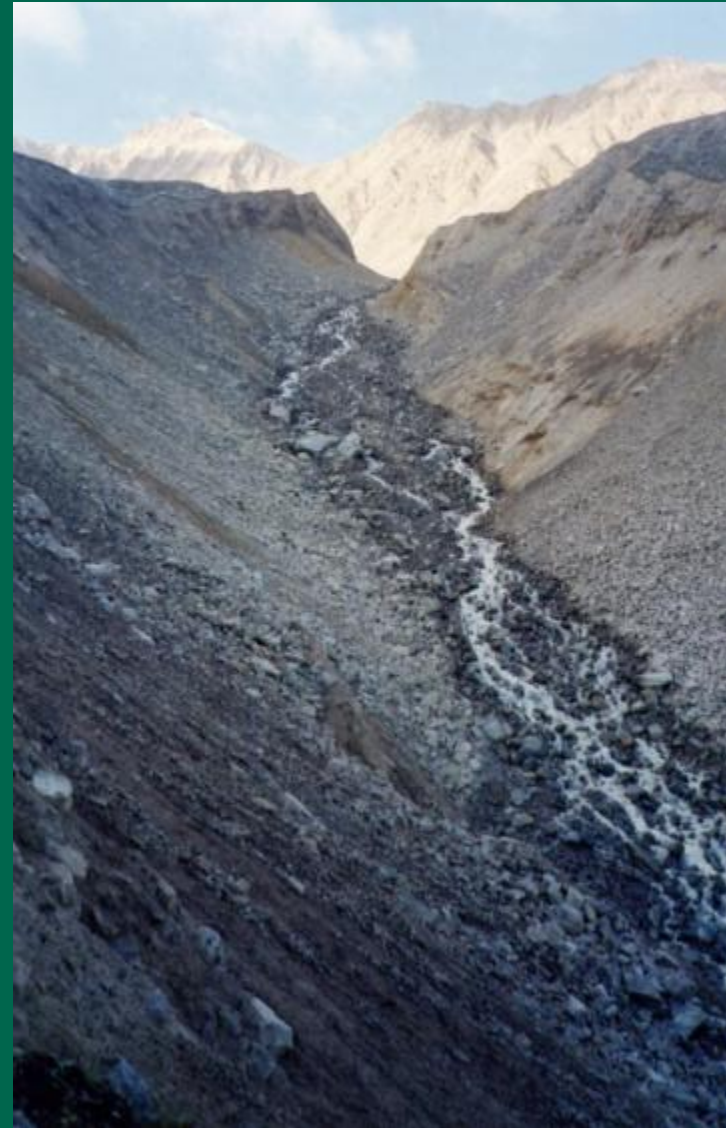
## Changes 1 year after the disaster

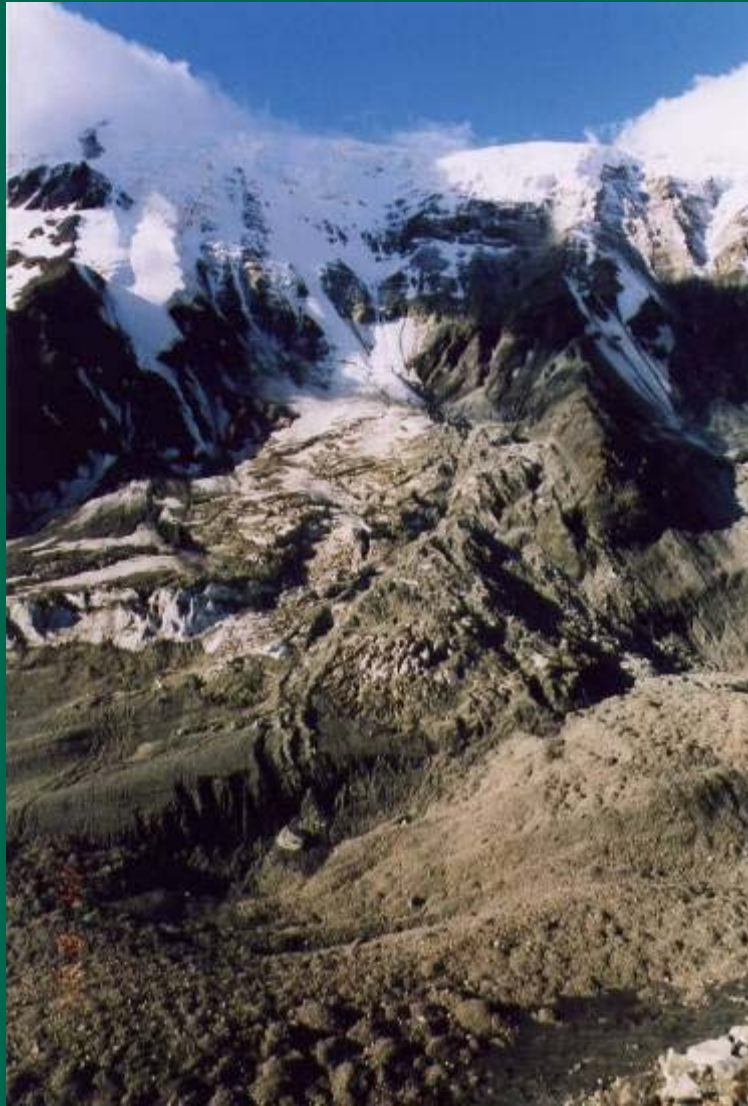
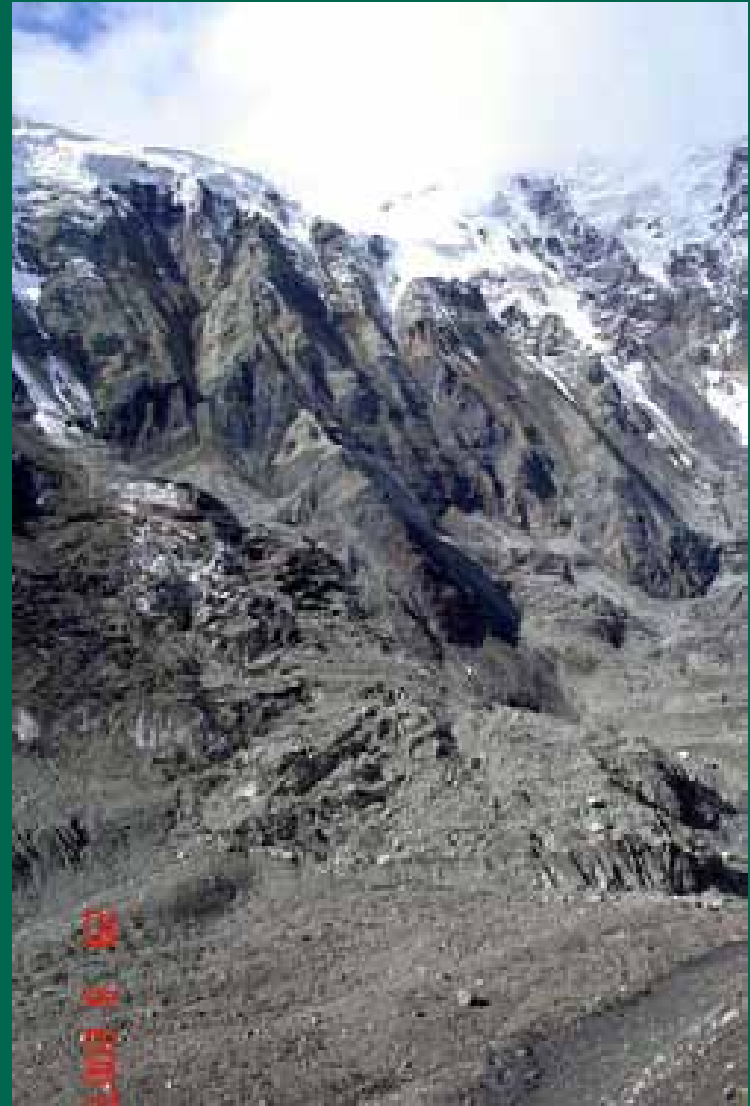
## Advancing glacier

2004

2007

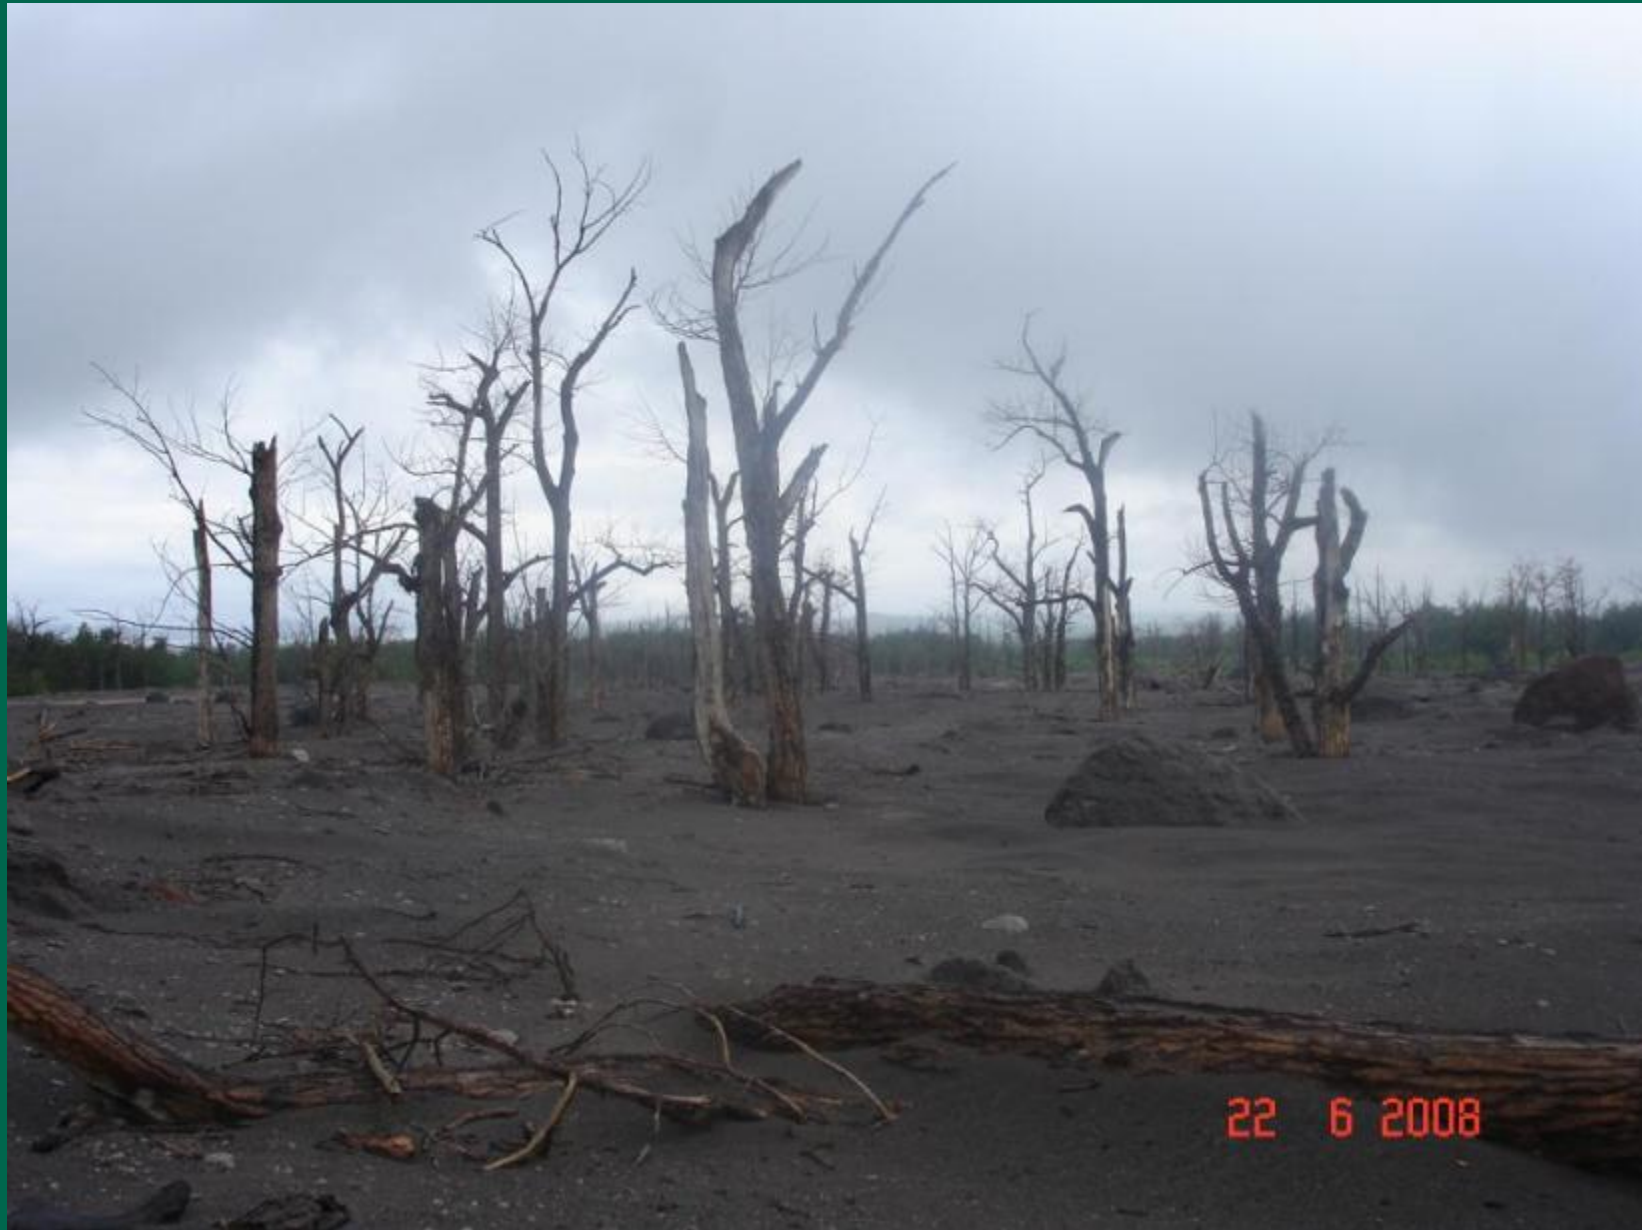
## Shiveluch Volcano: lahar deposits

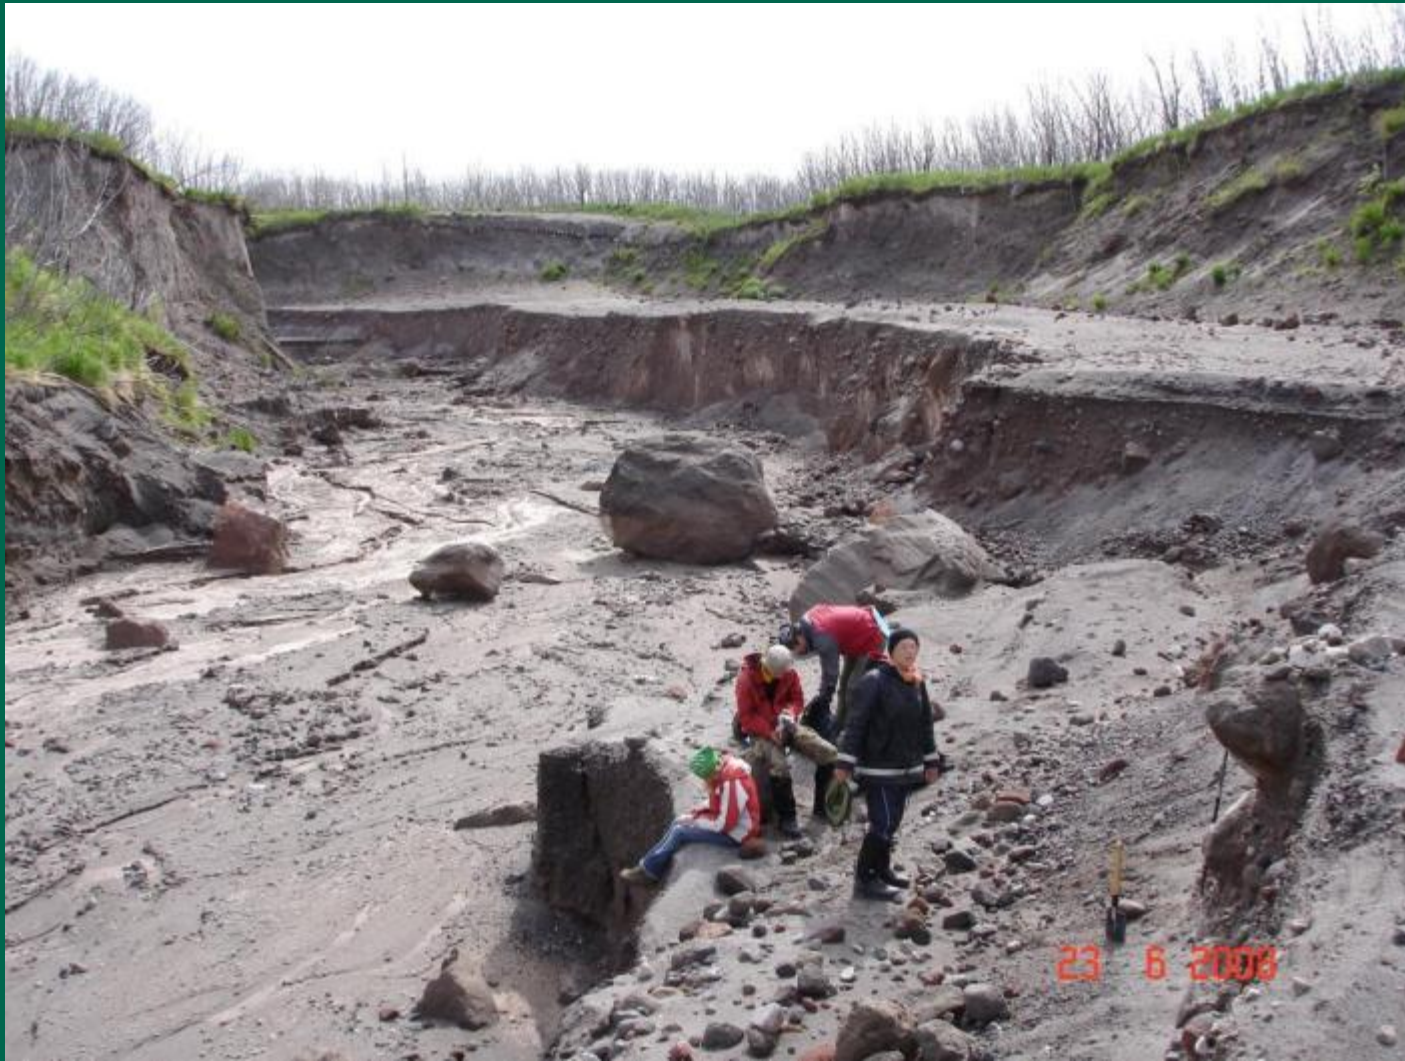
## Shiveluch volcano: lahar deposits

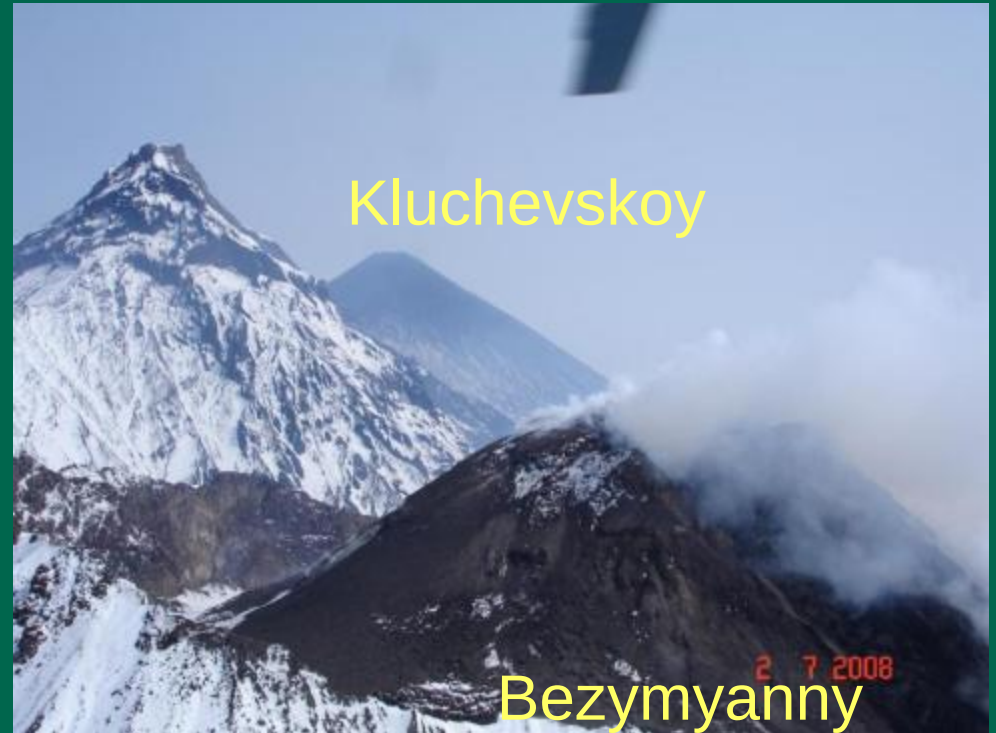
# Debris flow formation in NE slope of the Klyuchevskoy volcano

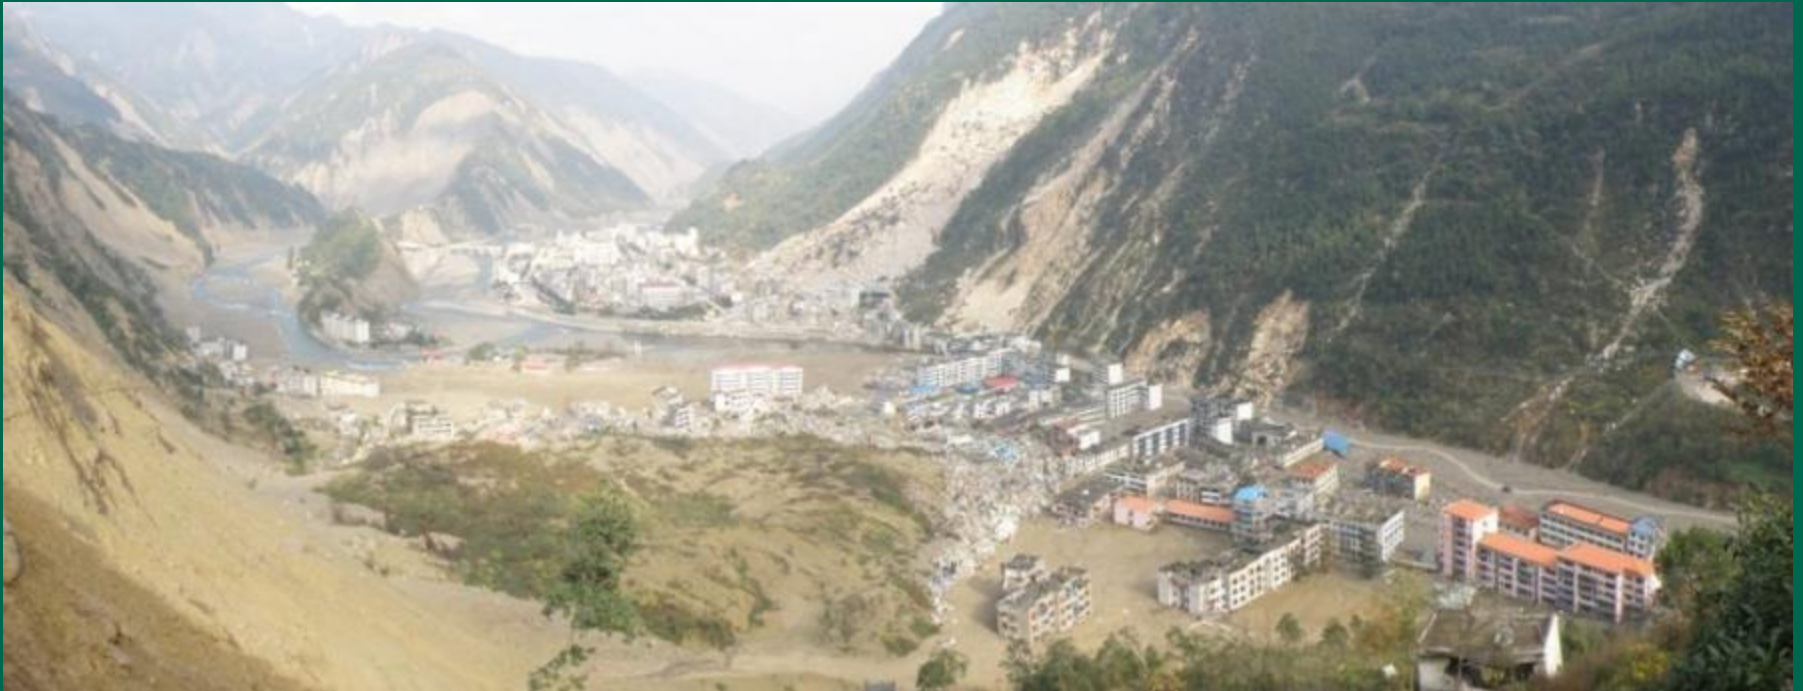
## Beichuan: landslides and rockfalls

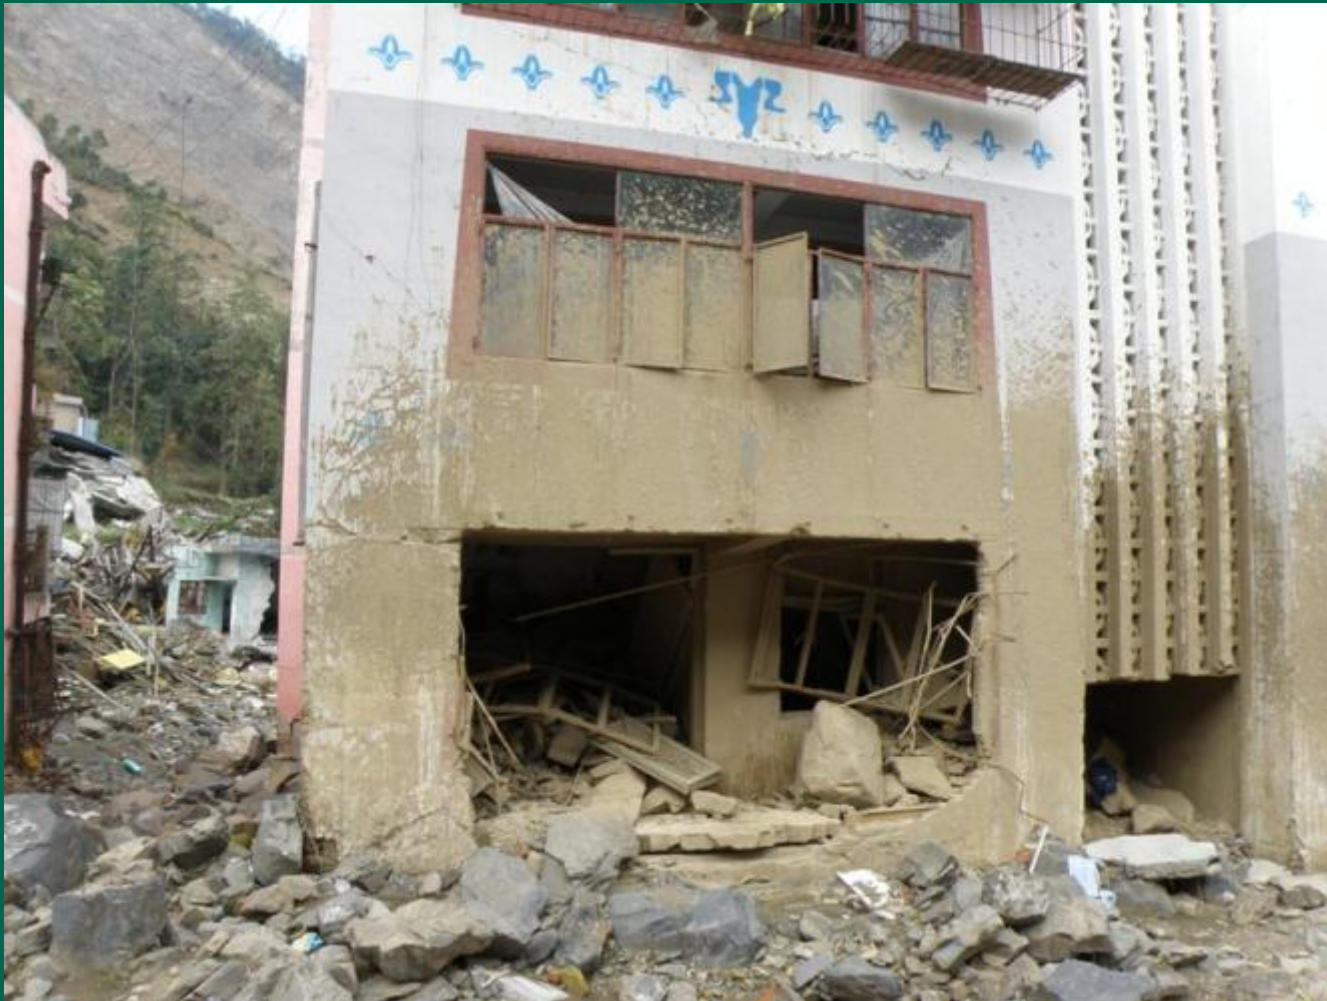
## Deposits of the 24 September 2008 debris flow. Beichuan

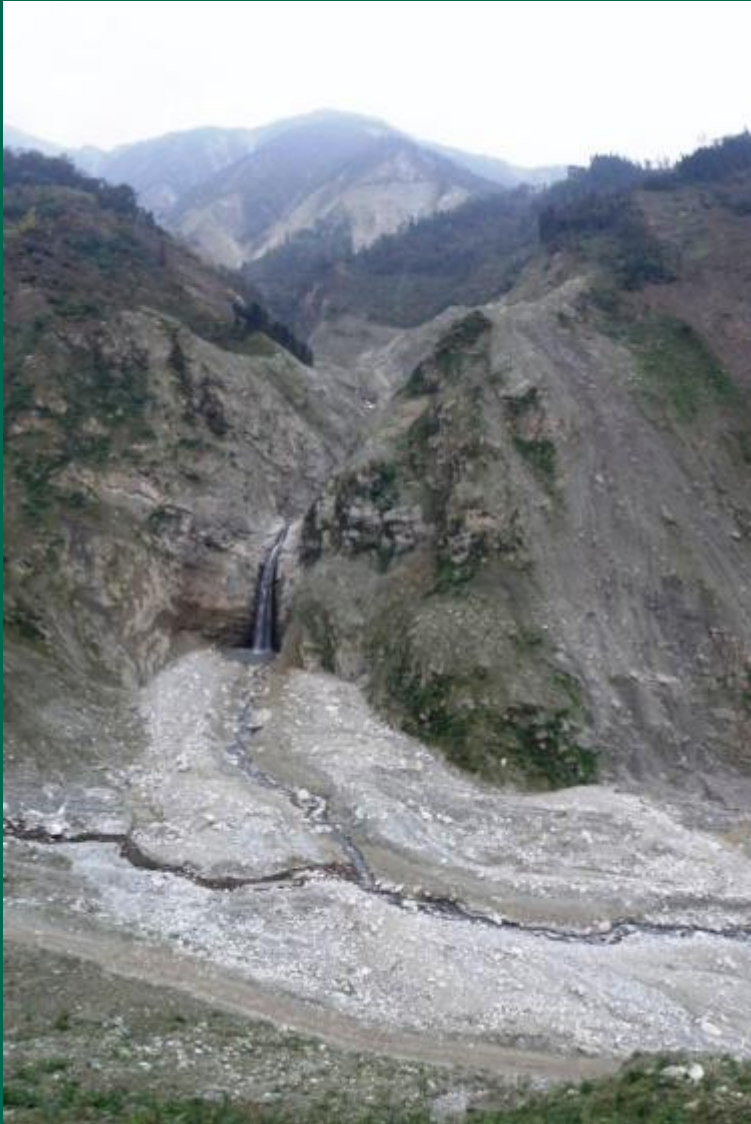
Debris avalanche in the epicentre area  
The Lianhuaxigou River  
and the Niujuangou River  
near Yingxiu

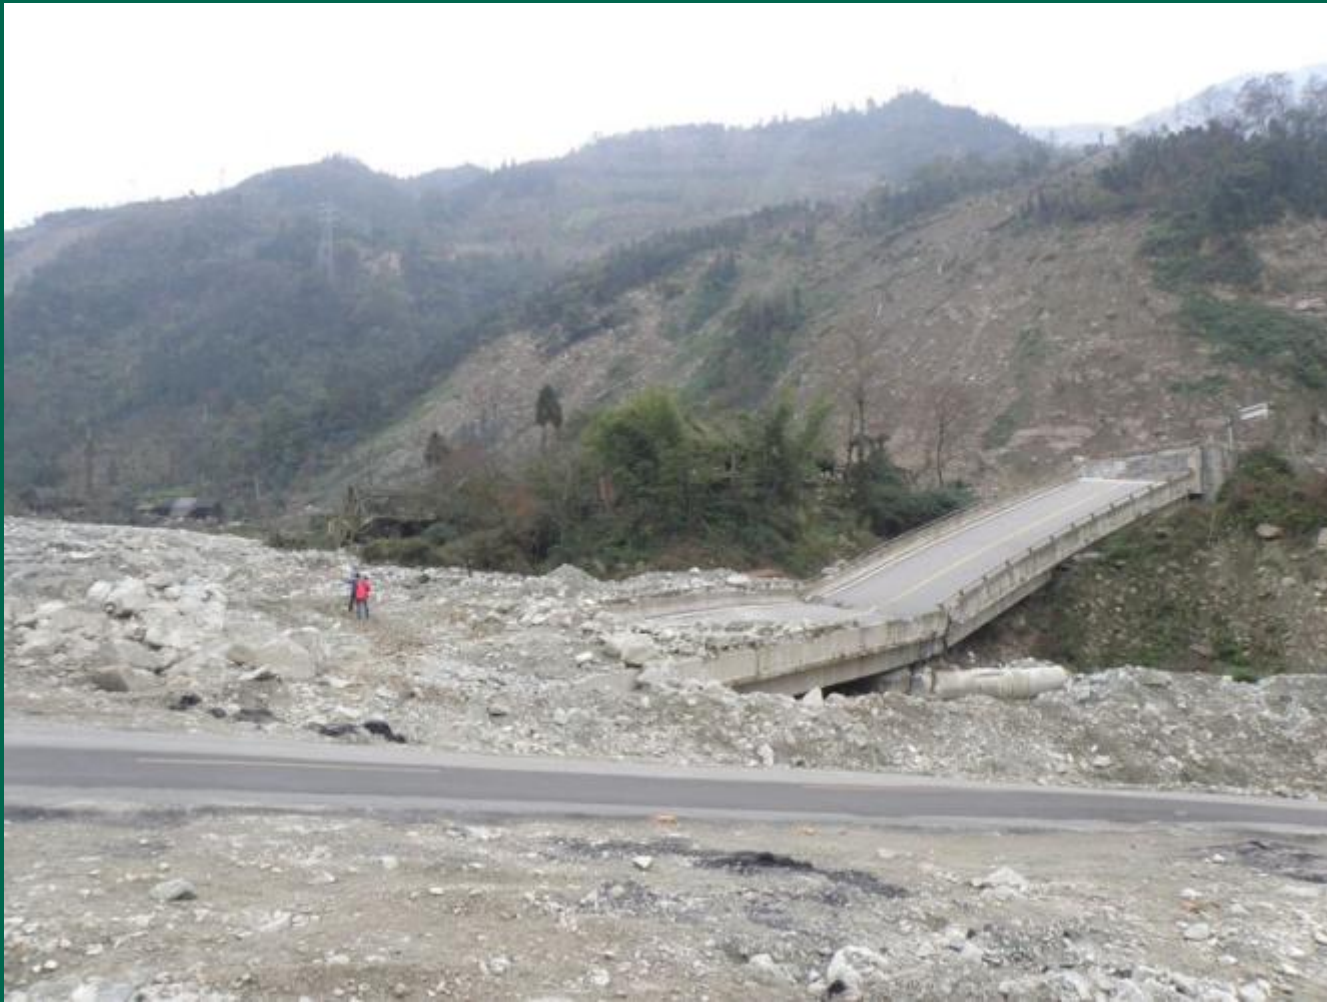
## Deposits of a debris flow, which occurred after a cyclone on 25-27 September 2008. The Nijuangou River, Yingxiu County

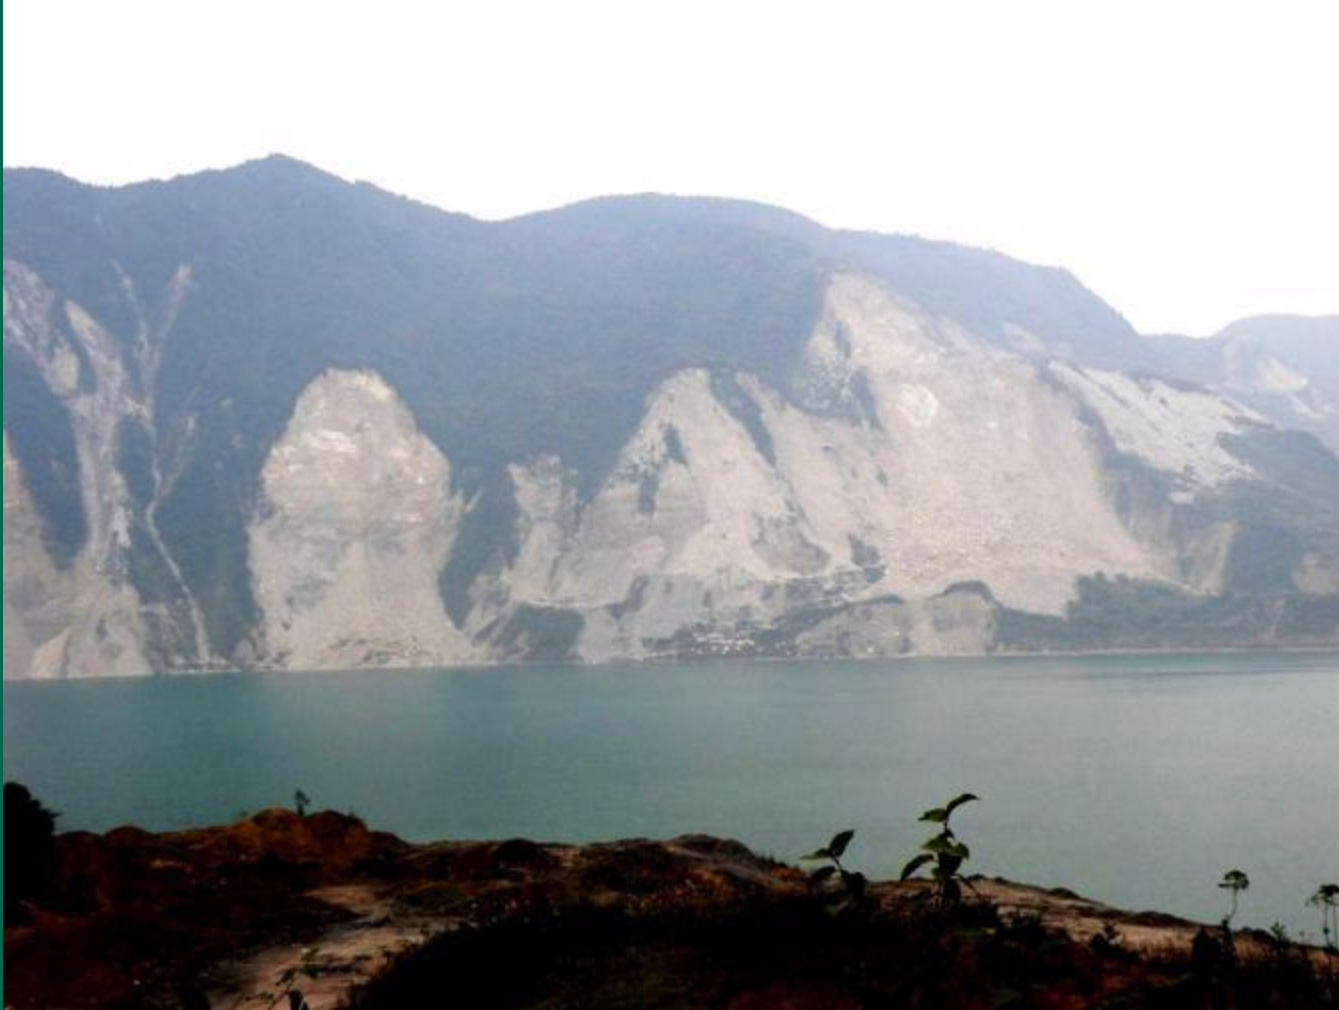
## Zipingpu: rockslides above the reservoir

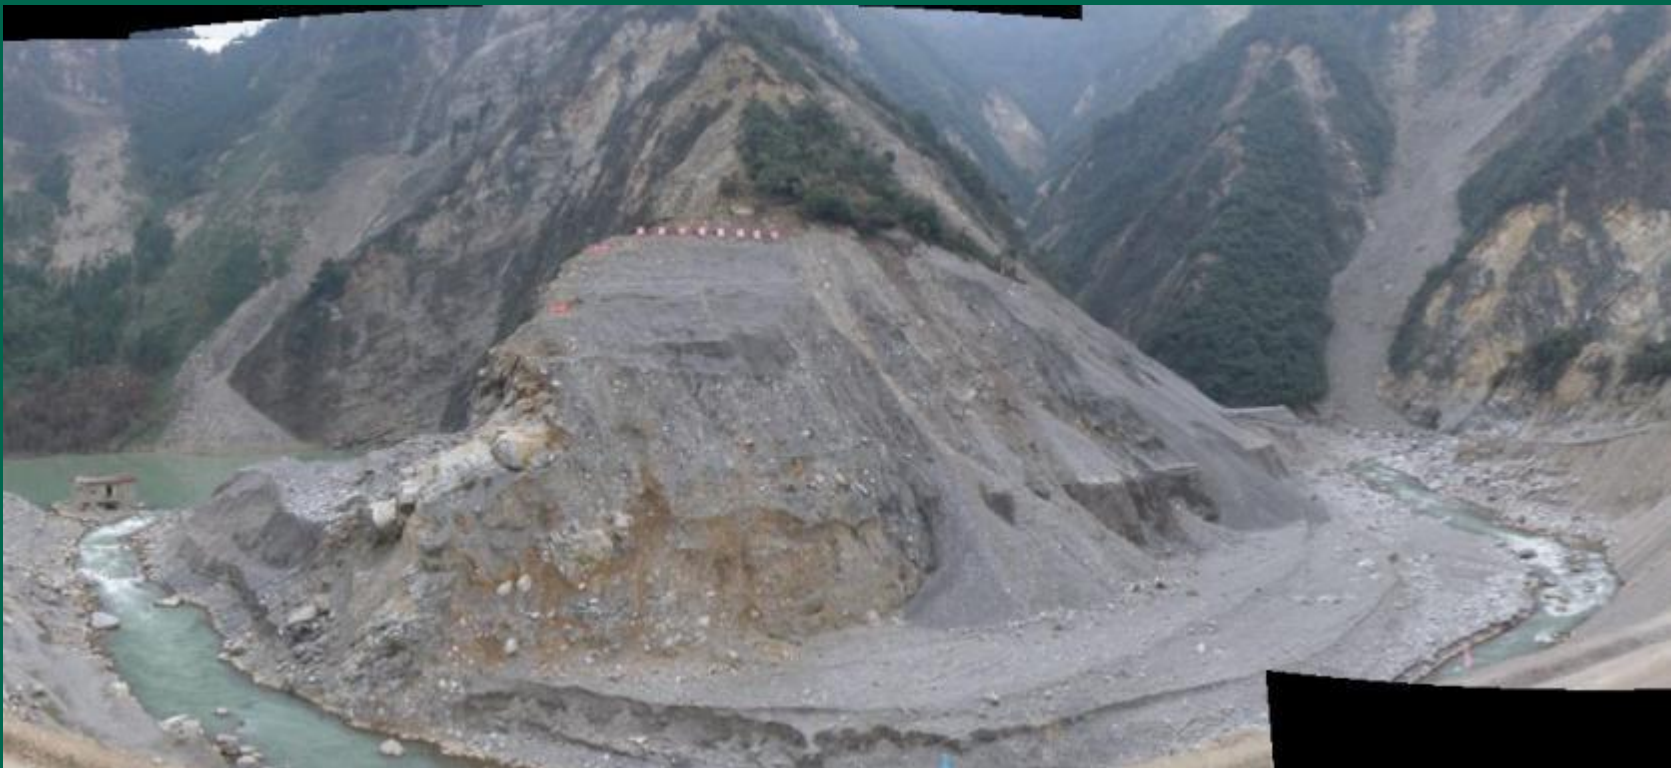
New dammed lake on the Chaping River:  
channel incision and water level drop after creation of an  
artificial spillway

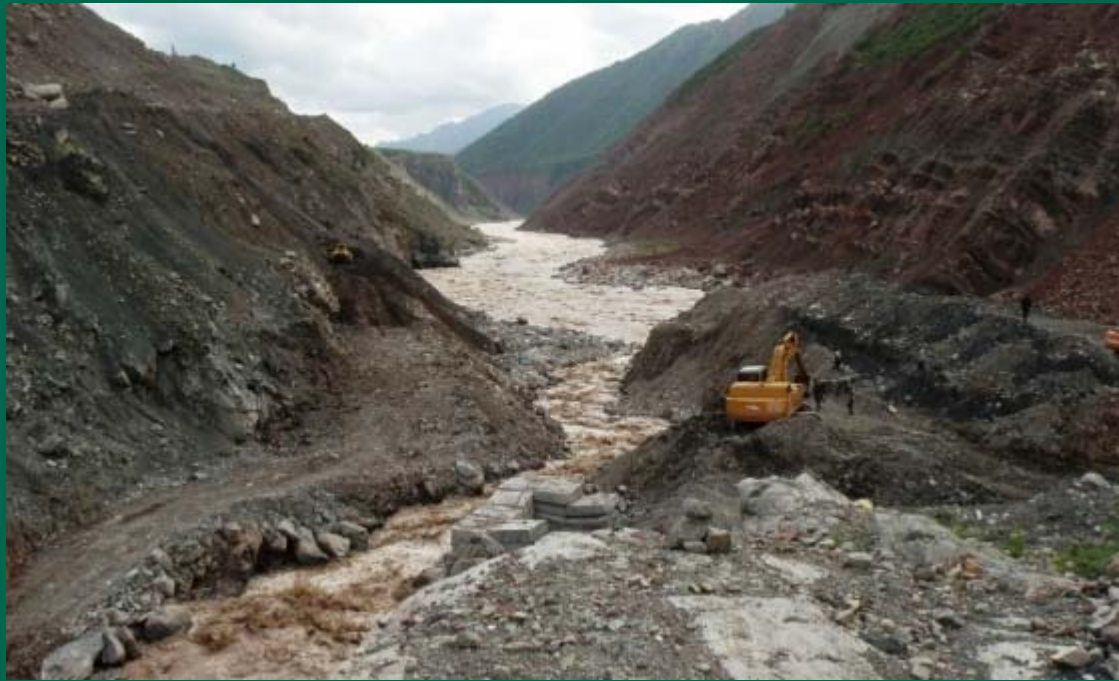
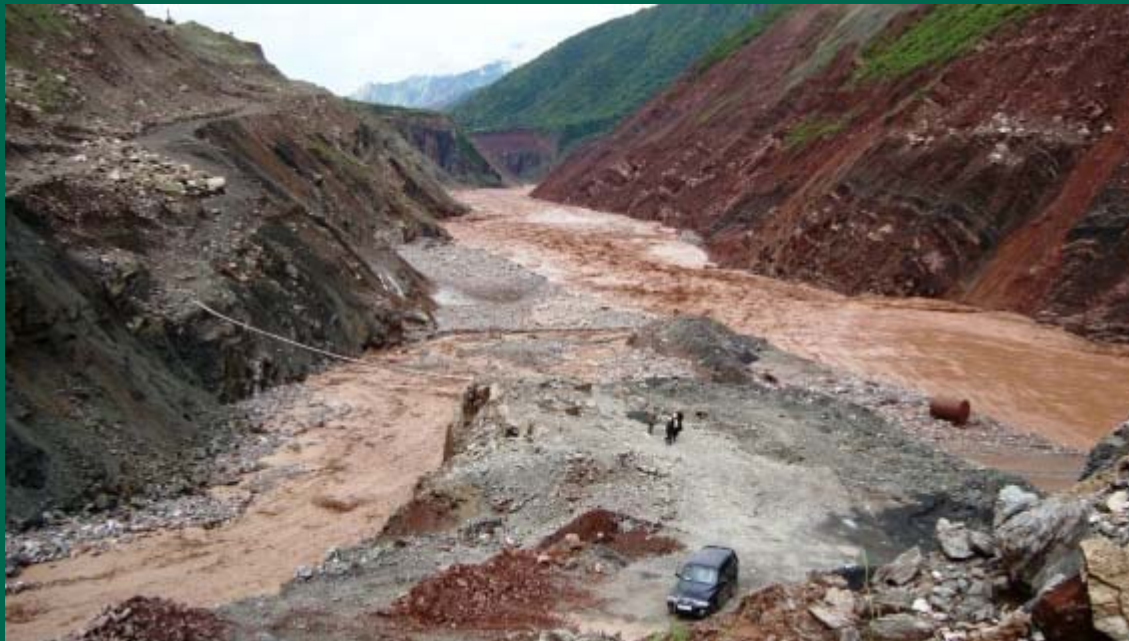
# Rogun: Obishur and Vakhsh rivers before and after 19 May 2009 debris flow

Rogun:  
flooding of tunnels.

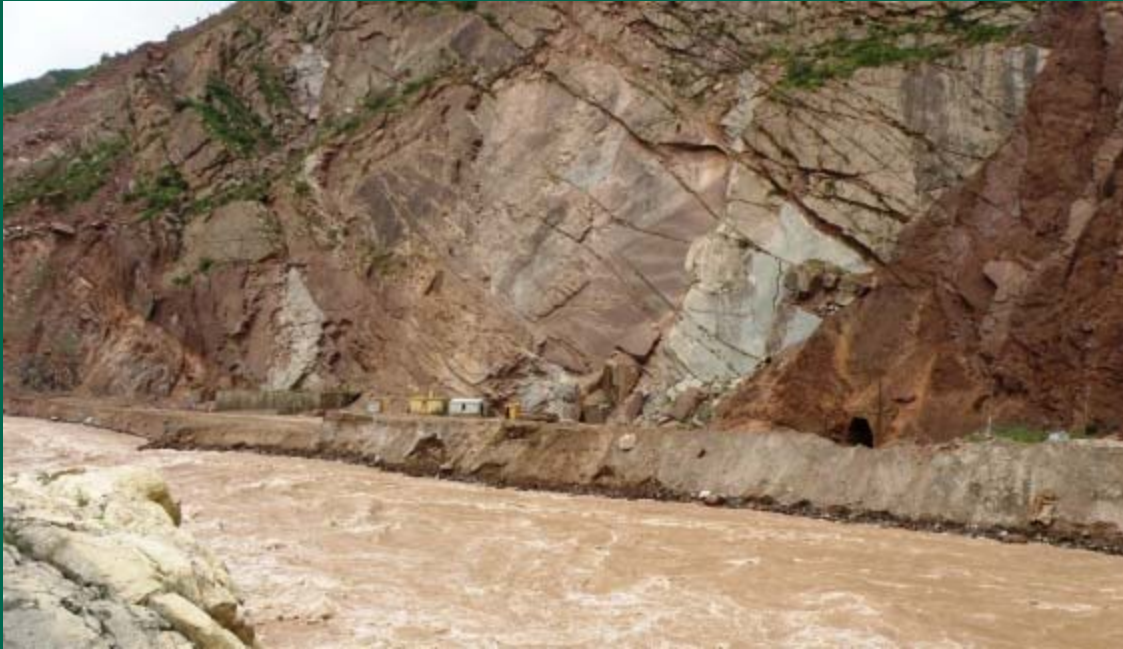
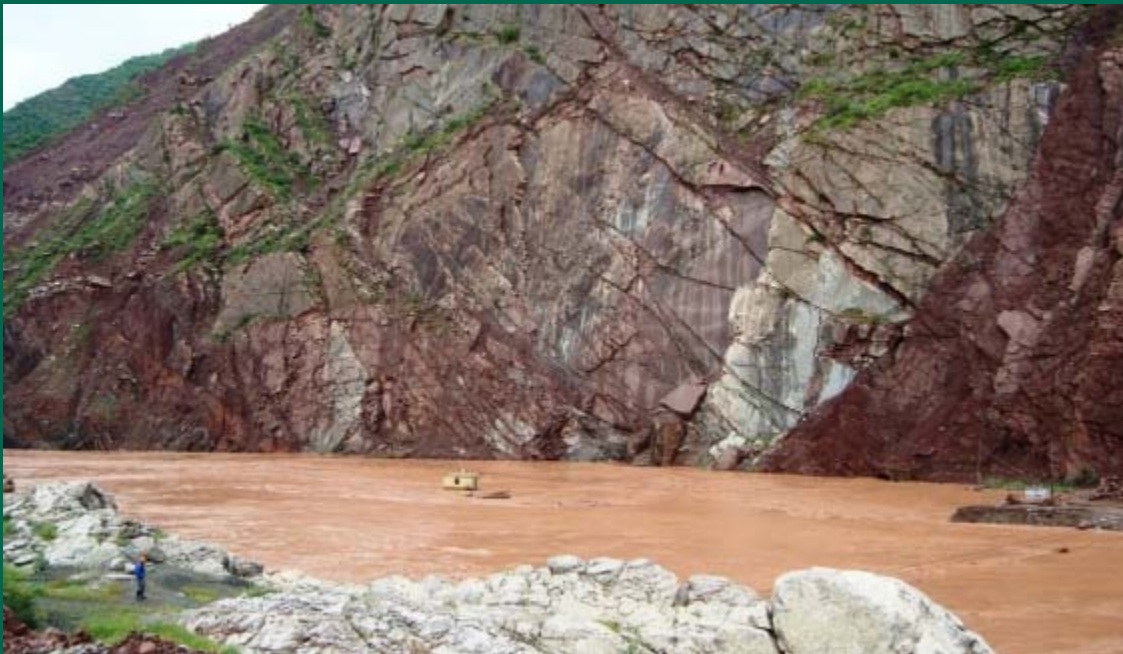
Vakhsh River  
before and after  
19 May 2009  
debris flow on  
Obishur River

Rogun:  
flooding of tunnels.

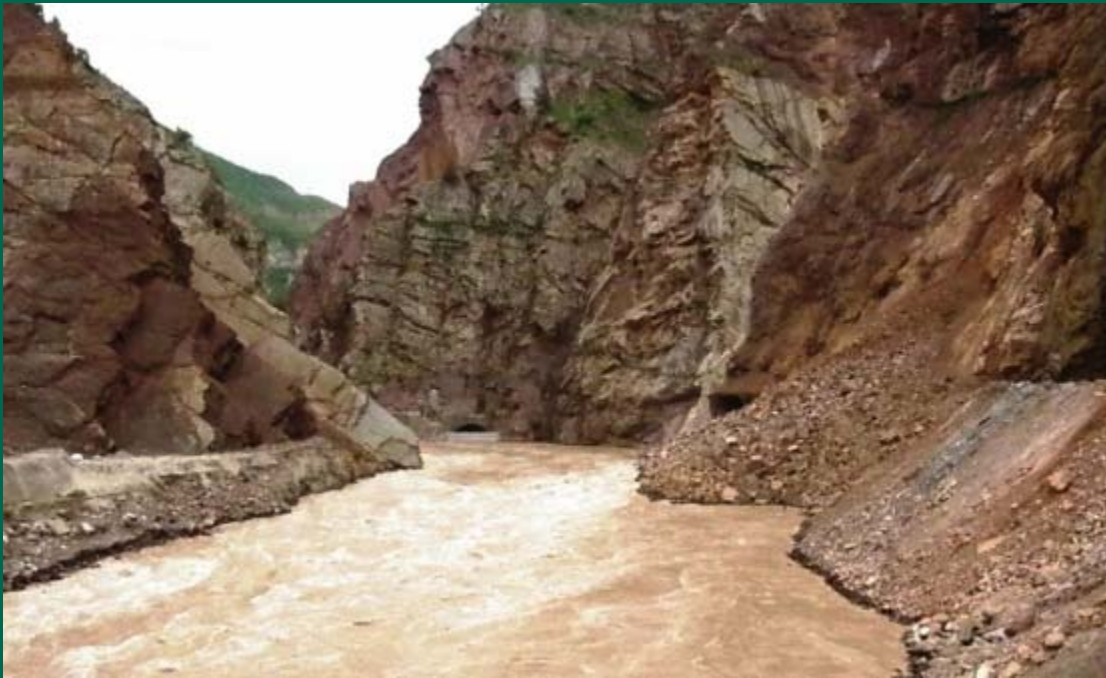
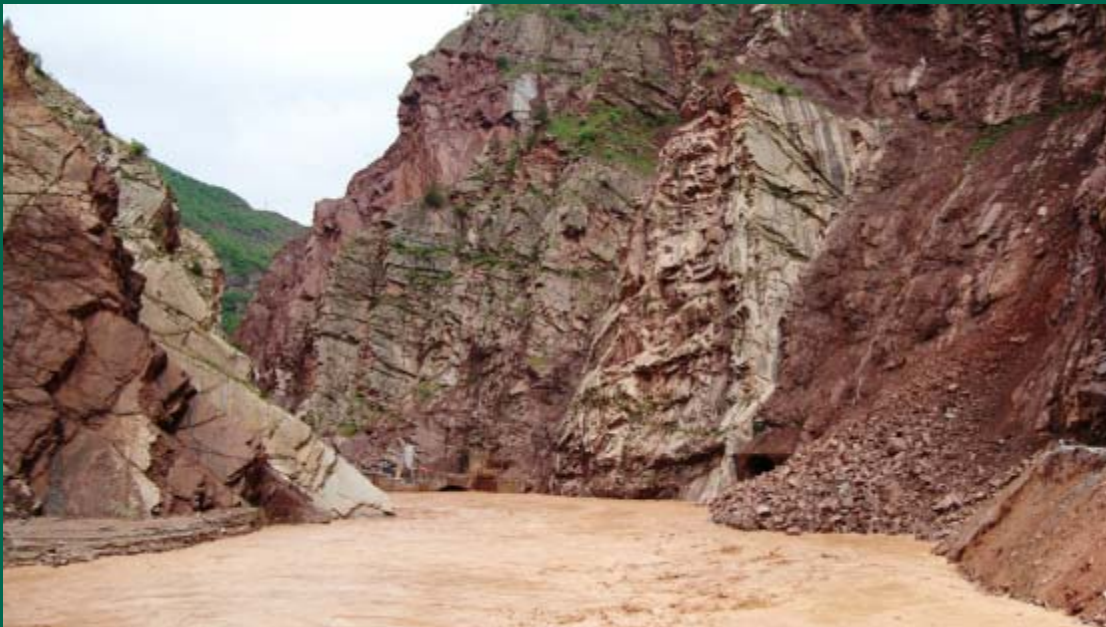
Vakhsh River  
before and after  
19 May 2009  
debris flow on  
Obishur River

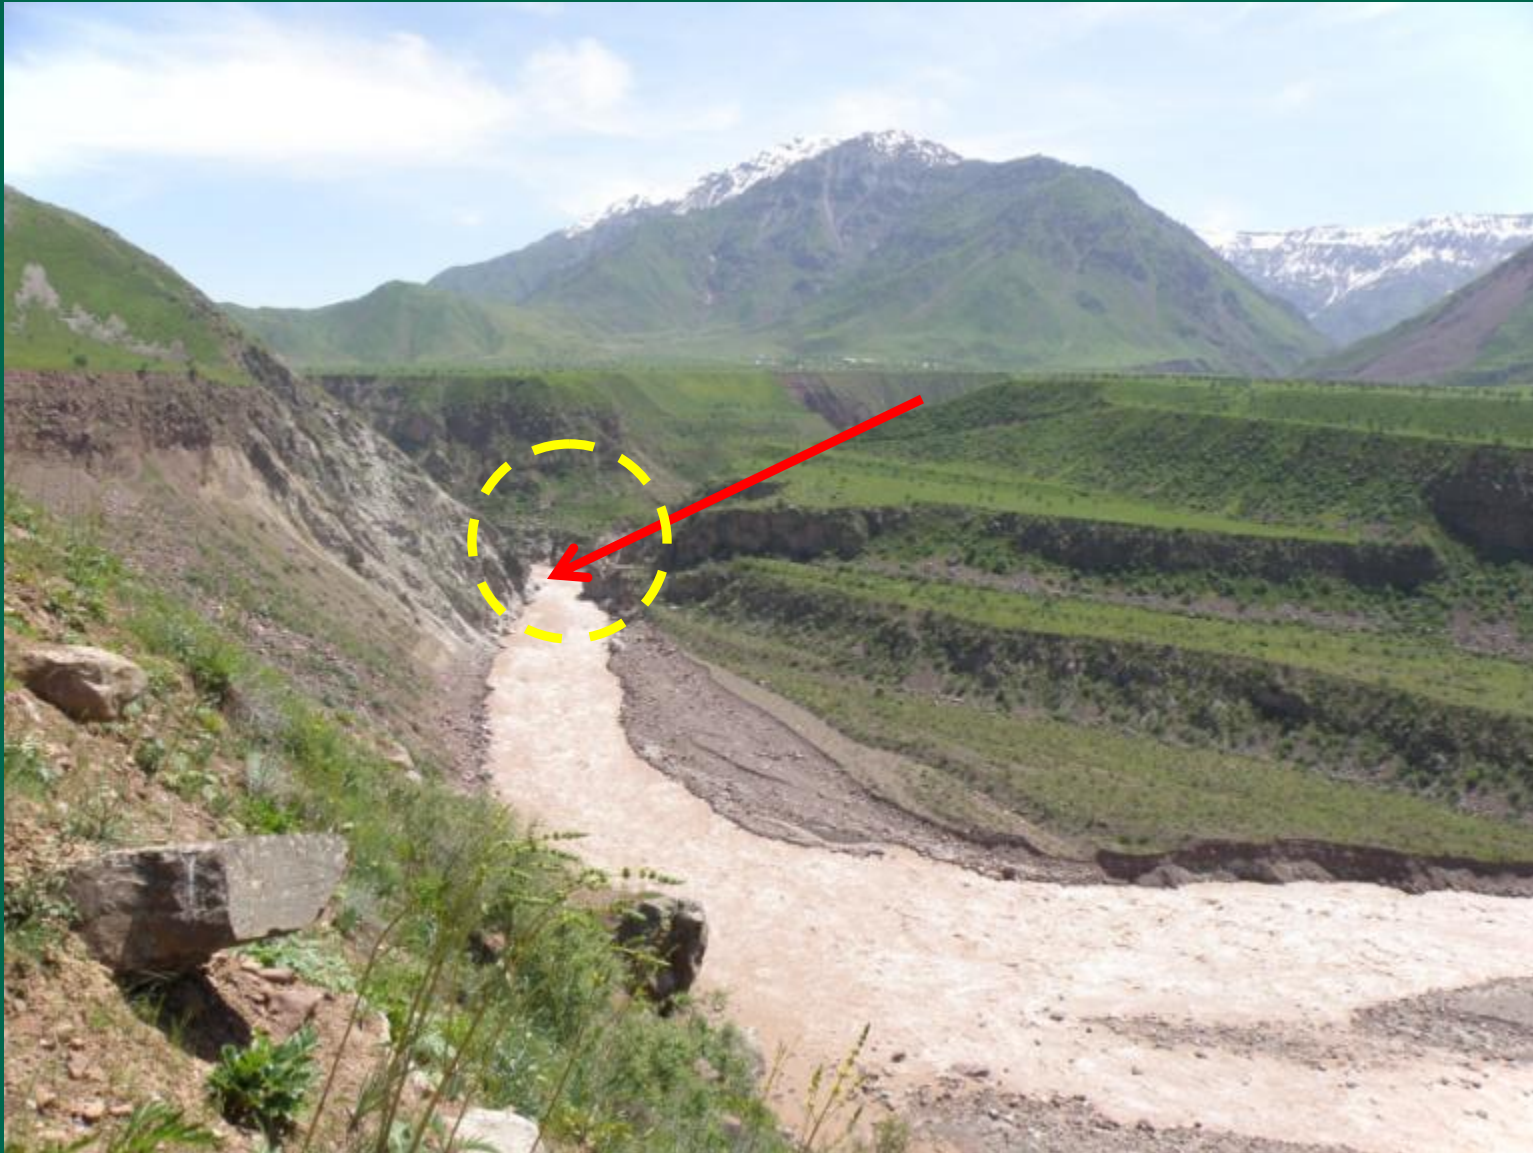
## Place of blockages of Vakhsh River by debris flows from Daraykomok River
